GTR Lighting Knowledgebase Article: Premature Failure with Buick Rainier LED Eyebrow Lights When installing a low-load LED bulb replacement in the Buick Rainier or similar vehicle, you may run into a problem with the LED burning out often with the headlight "Eyebrow" light accents.

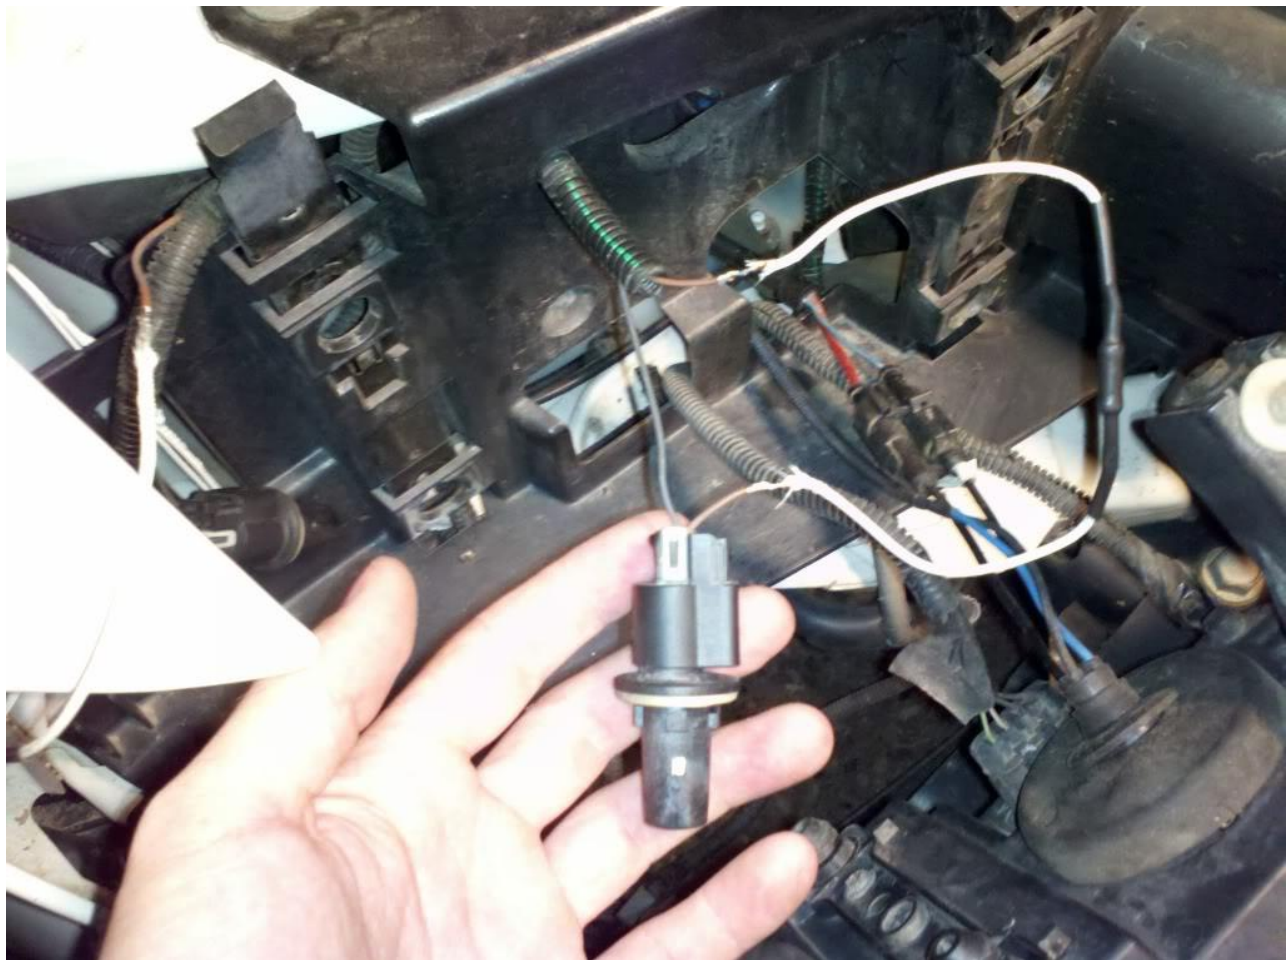
This happens because when the truck first starts up the alternator (which is controlled by computer) is pushing out more than 14 vdc, maybe 15.5 or 16 vdc. If this happens multiple times over the course of several days the LED bulbs can get damaged.

What needs to be done is to install a small 100 ohm resistor in line with the positive wire. **DO NOT WIRE IT IN PARALLEL WITH POWER AND GROUND!!**

Simply cut the positive wire and install the resistor in line with only the power wire.
